Investigation Report for Ink Stain of EPPI IJP 5162342-00 Dice 2-5 LH Individual Box

CONTROL No:	IRF - 23-11-0104			REJECT PERCENTAGE:	10.00%
REJECT QTY:	80	LOT QTY:	800

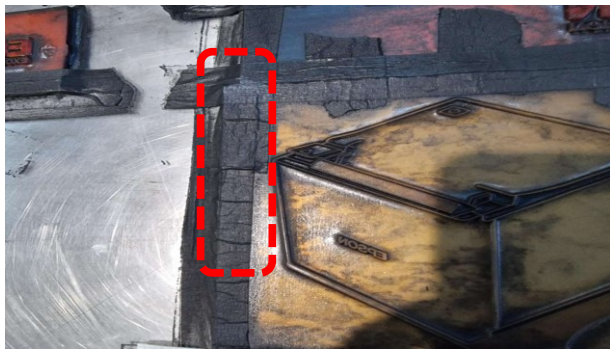
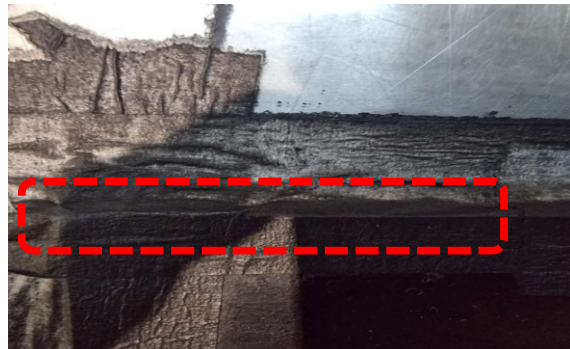
DIRECT CAUSE	W1	The edges of cyrel base for black print touch the anilox then touch the item that caused ink stain.
	W2	The edges of cyrel base lifted during mass production.
	W3	The tape adhesive got weak possible due to cyrel cleaning using water.

LIFTED PORTION OF CYREL BASE FOR BLACK PRINT

Orient the operator as awareness regarding this issue.	PIC:	Production Leader	TARGET DATE:	231117
Cleaning, re-adhesion and re-layout of cyrel.	PIC:	Tooling Custodian	TARGET DATE:	231116 (Done)
Ensure the print alignment next running, then after the process tooling custodian apply sealant to the cyrel base so the adhesive does not wet during cyrel cleaning.	PIC:	Tooling Custodian	TARGET DATE:	Next Running (No open schedule)

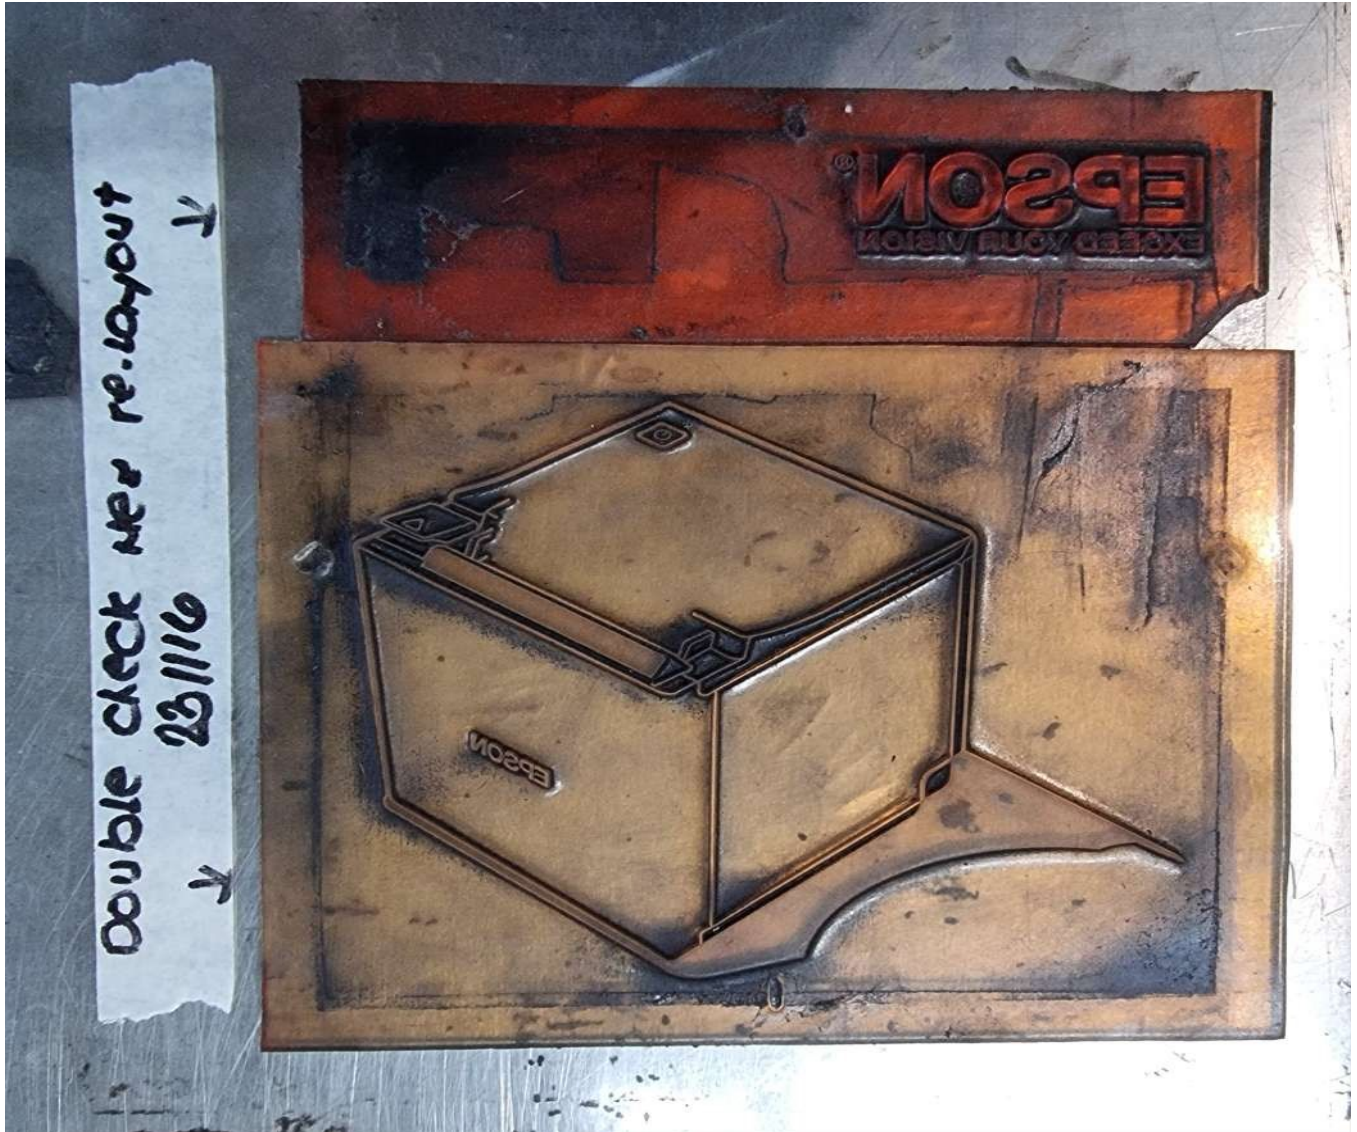
CYREL ALREADY CLEAN, RE-ADHESION & RE-LAYOUT
