KANEPACKAGE PHILIPPINE INC. No. 5 Ring Road LISP II, Brgy. La Mesa, Calamba City, Laguna Telephone No. (049) 545-7166 to 69 Fax No. (049) 545-6302	INVESTIGATION REPORT		
	Prepared By:	Check By:	Approved By:
	K.DIAZ QA-IE/ Prodn IE	N. CEPEDA QA/ Prodn SV	R. MIRANDA KPLIMA Operations Gen. Mngr.
DATE:	JUNE16, 2023

1.1. ISSUE:	
	NO CREASING MATRIX
1.2. ITEM DESCRIPTION:	
PART CODE:	516378900
PART NAME:	LIME 2 MB AMERICA
1.3. BACKGROUND:

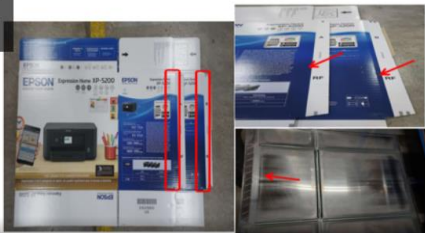
DETAILS: >Inhouse Detection : NO CREASING MATRIX >Lot size: 348pcs > Reject Qty: 348pcs >Rejection Rate: 100% >JO#: 37836

WHY 1:	NO CREASING MATRIX OCCUR AT DIE-CUT MACHINE FOR THE ITEM 516378900 LIME 2 MB AMERICA WITH 100% REJECTION RATE
WHY 2:	WHILE RUNNING, PARTS OF THE PLATE DO NOT HAVE A CREASING MATRIX. NOTE:THE QA PERSONNEL ALSO FAILED TO NOTICE THAT THE LIME ITEM'S HAS NO CREASING MATRIX, SO ORDERED TO DO MASS PRODUCTION.
WHY 3:	THE OPERATOR DID NOT NOTICE THAT THE SOME PART CREASING MATRIX LOSS OF ADHESION TO THE PLATE
WHY 4:	THE PLATE ON THE RACK WAS LAYING ON TOP OF ANOTHER, CAUSING THE ADHESION OF THE CREASING MATRIX TO BE REMOVED WHEN THE OPERATOR GET AND RETURN ON THE RACK.

ACTION ITEMS	Target Date:	Person In-charge
AFTER THE RUNNING THEY PLACED THE CREASING MATRIX ON THE PLATE	230607	TOOLING

1	REPLACEMENT OF CREASING MATRIX	PIC: OPERATOR Target Date: JUNE 7, 2023
2	ORIENTATION TO DIECUT OPERATOR REGARDING THE ENCOUNTERED 100% REJECTION RATE IN LIME DUE TO NO CREASING MATRIX	PIC: Production IE Target Date: JUNE 16, 2023
3	REMIND OPERATOR ABOUT THE IMPORTANCE OF ALWAYS CHECKING THE CONDITION OF EQUIPMENT AND ITS CHECK POINTS (BLADES, CREASING MATRIX, PLATES ETC.) THAT IS BEING USED DURING MASS PRODUCTION	PIC: Production IE Target Date: June, 2023
4	IMPROVE THE PLATE RACK IN THE AREA	PIC: Production IE Target Date: -
