Eterna's Diechase Update

Previous Condition

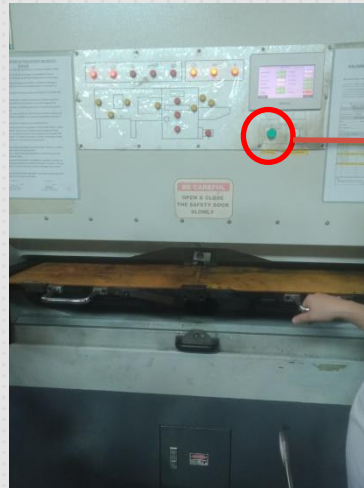
Eterna's diechase encountered movement while on-lock motion which causes problem on misalign cut. Prior this incident, the diechase stays in place even when operators pull it forcefully.

Die chase is on-lock motion but is not locked properly.

Die chase should be locked when the button is not switched on.

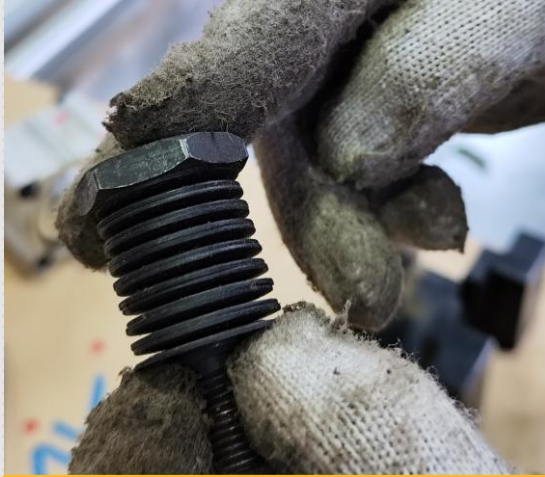
Old and worn out diechase spring

Caledonian visited KPPI yesterday, July 31, to conduct fixing of the diechase springs.

- Installation of the 6 springs started @1345H.
- Trial Run commenced @1930H and based on observation, the diechase now stays in place even with application of forceful pulling. Also, there was no movement on the diechase during running, however it will stay under observational status for other problems that may occur.

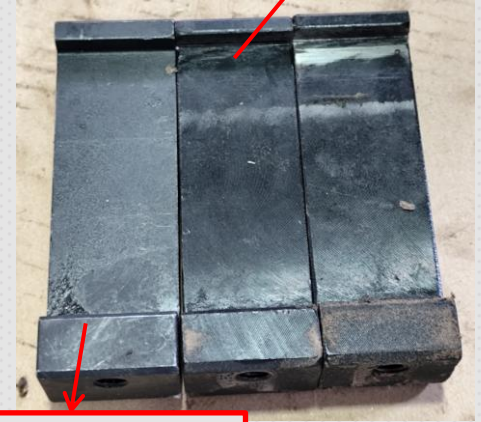
Old metal bar on the cylinder with scratches

New metal bar

*The metal bar that connects the spring on the diechase was also replaced as the old already has scratches.
