Investigation Report for Worn Out & Peel off of Denso PH989702-0721 Box

CONTROL No:	IRF - 0056			REJECT PERCENTAGE:	2.86%
REJECT QTY:	20	LOT QTY:	700

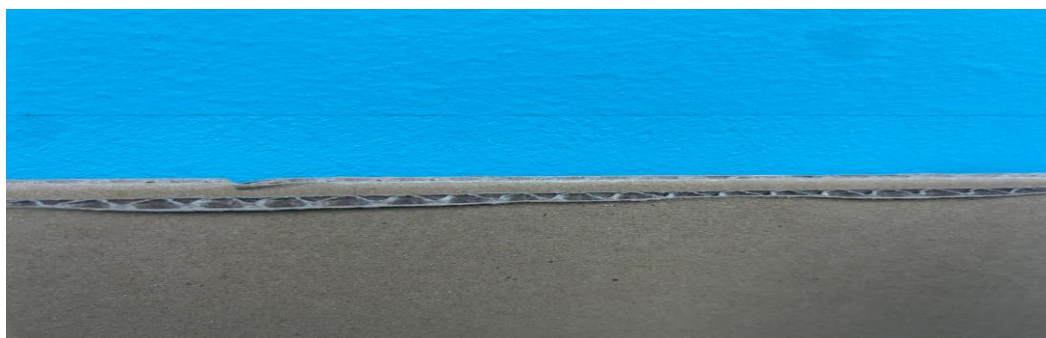
DIRECT CAUSE	W1	The edges of the board hits the feeder gate of Eqos that caused Worn Out & Peel Off.
	W2	The edges of the board are delaminated up to 3-5mm.

IMMEDIATE ACTION	Eqos feeder conduct pre-folding upon detection. (This action is temporarily since its effect on the productivity)	PIC:	Production	TARGET DATE:	250131
CORRECTIVE ACTION	Coordinate the issue to Supplier, SunPack (C/O QA)	PIC:	QA	TARGET DATE:
