INVESTIGATION REPORT FOR MISALIGNED CUT OF 516512900 LIGHT MB US

DIRECT CAUSE METHOD (PROCESS)

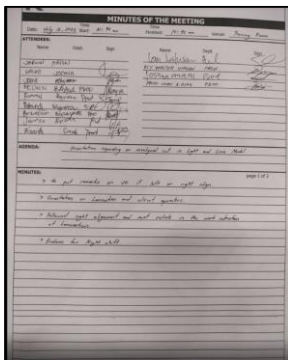
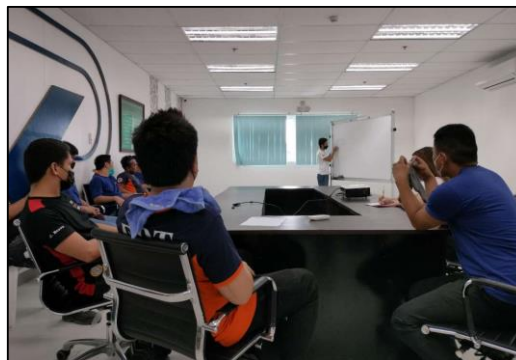
- W1: Misaligned cut occurred due to excess PS and SF.
- W2: Encountered problem in setting-up of side guide on diecut machine.
- W3: The problem were connected in Lamination alignment.

- > To put remarks on JO if left or right alignment
- > Lamination and diecut operators will followed right alignment
- > Meeting with Lamination and Diecut operators
- > Endorsement for night shift.
