| KANEPACKAGE PHILIPPINE INC. No. 5 Ring Road LISP II, Brgy. La Mesa, Calamba City, Laguna Telephone No. (049) 545-7166 to 69 Fax No. (049) 545-6302 | INVESTIGATION REPORT | | |

I. PROBLEM DESCRIPTION

| PART CODE: | 516592600 |
| PART NAME: | LOUVRE 2 MJX |

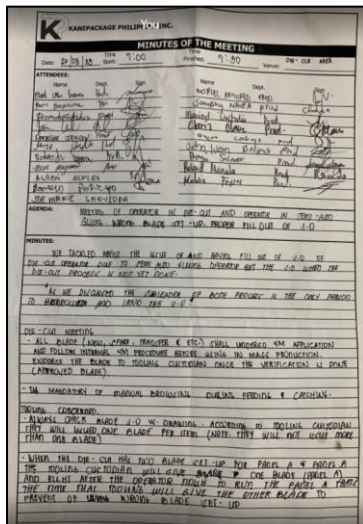
| WHY 1: | DAMAGED OCCURRED ON THE LOWER PART OF THE ITEM. |
| WHY 3 | UPON CHECKING THE BLADE,THE DIEBLADE SHOTS HAS 280K+ AND THE NICKMARK IS ON THE BLADE'S BRIDGE MIGHT CAUSE TO BROKEN BLADE. |
| WHY 4: | THE OPERATOR DID NOT NOTICE THAT THE DIEBLADE WAS BROKEN AND BYPASS THE MANUAL BROWSING/CHECKING OF AN ITEM CAUSING HIGH MASS REJECTION. |

| 1 | ORIENTATION FOR TOOLING CUSTODIAN AND DIECUT OPERATOR REGARDING FOR DAMAGED ENCOUNTERED. |
| 2 | THEY WILL JUST PLACE A NICKMARK AWAY FROM THE BRIDGE IF THE BLADE IS NEW AND DOESN'T HAVE ONE AND ALSO IN THE EXISTING BLADE. |
| 3 | RESTRICT OF MANUAL BROWSING/CHECKING DURING FEEDING AND CATCHING OF THE ITEMS. |
