Investigation Report: Damage on 5163364-00 Muffin Box

CONTROL No:	AR-10-0005			REJECT PERCENTAGE:	4.00%
REJECT QTY:	24	LOT QTY:	600

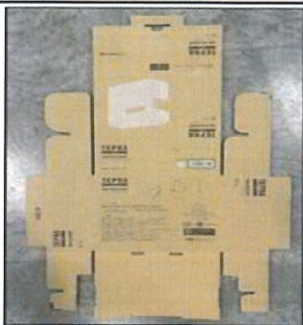
GOOD :

DIRECT CAUSE	W1	Damage occur during manual stripping process
	W2	During pulling of scrap material the affected portion also pulled out causing damage
	W3	The affected portion has no cutting blade
	W4	The stripping process of the scrapp is not considered during the design of the die cut blade

IMMEDIATE ACTION	Orient the operators regarding proper manual detaching	PIC:	Production leaders	TARGET DATE:	October 6, 2025
CORRECTIVE ACTION	Attached sutera blade to have cutting on the affected portion and sperate it during pulling of outer scrap	PIC:	Production Toolings	TARGET DATE:	October 6, 2025
