**KANEPACKAGE PHILIPPINE INC.**

INVESTIGATION REPORT FORM (IRF)

Customer	KOWA-EMORI PHILIPPINES, INC.	Attention To	REXEL ALMARIO
Item Code	HP01D2200C-1	Department	PRODUCTION
Item Description	CARTON BOX W/ PRINT	Date of Detection	241210
Job Order Number	JO24-M-02017-45	Section Detected	QA SCREENING 4

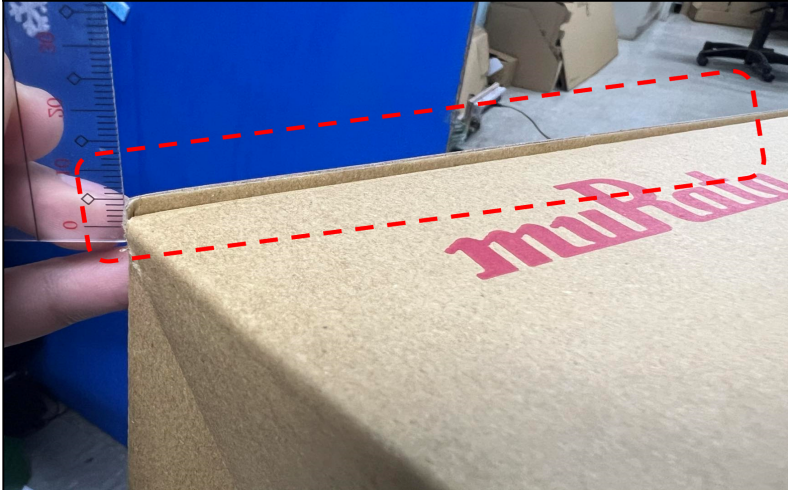
ILLUSTRATION OF THE PROBLEM

Lot Quantity (pcs)	Reject Qty (pcs)	Reject %
1360	48	3.53
Nature of Defect:		
OVER LAP		
Requirement:		
OVERLAP IS NOT ACCEPTABLE		
Actual		
OVERLAP UP TO 5MM

WHY 1 : W1 Operator pre folding the item due to encounter close gap overlap. r nW2 The installed creasing matrix on the vertical creasing line move during Eterna process that caused of misalignment during folding in gluing process. r nW3 Weak adhesion of creasing matrix installed.

WHY 1: Re installation of Creasing Matrix.
