**KANEPACKAGE PHILIPPINE INC.**

INVESTIGATION REPORT FORM (IRF)

Item Description PACKAGE

SMEARED PRINT

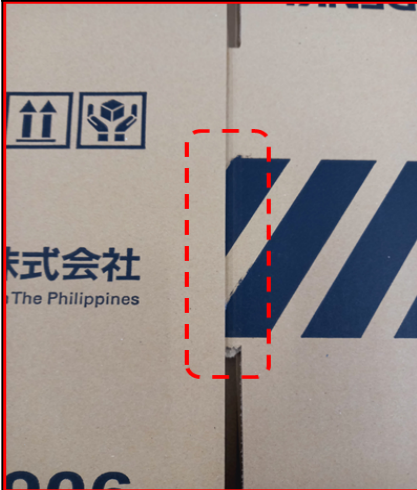
ILLUSTRATION OF THE PROBLEM

ACTUAL: With
smeared print
REQUIREMENT:
No smeared print

WHY 1 : W1 INK SPREAD FURTHER ON THE PRINTED AREA r nW2 ACCUMULATION OF INK ON THE EDGES OF FLEXO PLATE r nW3 DUE TO OVER PRINT IMPRESSION (ADJUSTMENT UPON TRIAL RUN)

Date Conducted: 2025-03-12	PIC: M.ASIS
Identified Rootcause Due to over pressure during print impression	Recommendation N/A

WHY 1: CLEANING OF CYREL UPON DETECTION OF SMEARED PRINT.

WHY 2: TRANSFER SOLID PRINT FROM UNIT 1 TO UNIT 2 AFTER THE INSTALLATION OF NEW UPGRADED ANILOX ROLLER.
