**KANEPACKAGE PHILIPPINE INC.**

INVESTIGATION REPORT FORM (IRF)

Control No.:		Date Issued	
0045		250107	
Customer	SANYO DENKI PHILS INC.	Attention To	REXEL ALMARIO
Item Code	00912906-01	Department	PRODUCTION
Item Description	PACKAGE	Date of Detection	250103
Job Order Number	JO24-M-02341-12	Section Detected	QA SCREENING

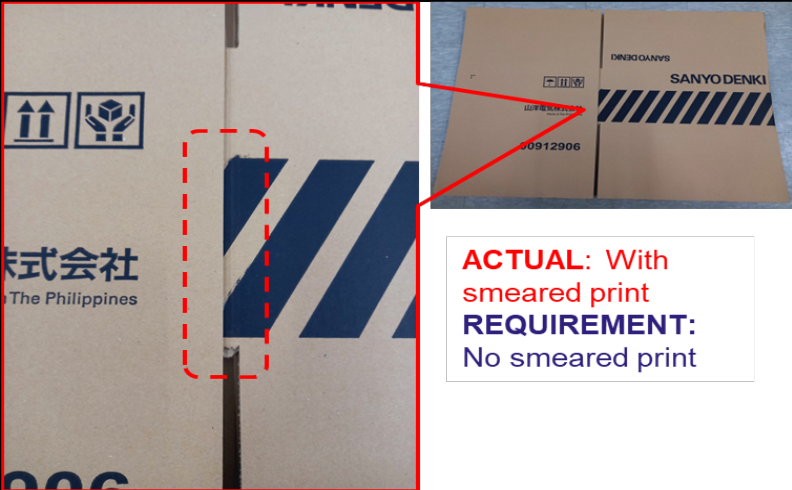
ILLUSTRATION OF THE PROBLEM

Lot Quantity (pcs)	Reject Qty (pcs)	Reject %
800	40	5.00
Nature of Defect:		
SMEARED PRINT		
Requirement:		
No smeared print		
Actual		
With smeared print

WHY 1 : W1 INK SPREAD FURTHER ON THE PRINTED AREA r nW2 ACCUMULATION OF INK ON THE EDGES OF FLEXO PLATE r nW3 DUE TO OVER PRINT IMPRESSION (ADJUSTMENT UPON TRIAL RUN)

WHY 1: CLEANING OF CYREL UPON DETECTION OF SMEARED PRINT.

WHY 2: TRANSFER SOLID PRINT FROM UNIT 1 TO UNIT 2 AFTER THE INSTALLATION OF NEW UPGRADED ANILOX ROLLER.
