**KANEPACKAGE PHILIPPINE INC.**

INVESTIGATION REPORT FORM (IRF)

Customer	ARKRAY	Attention To	REXEL ALMARIO
Item Code	84-05467A	Department	PRODUCTION
Item Description	INNER BOX F821629-1	Date of Detection	250403
Job Order Number	JO25-M-00876-3	Section Detected	QA SCREENING

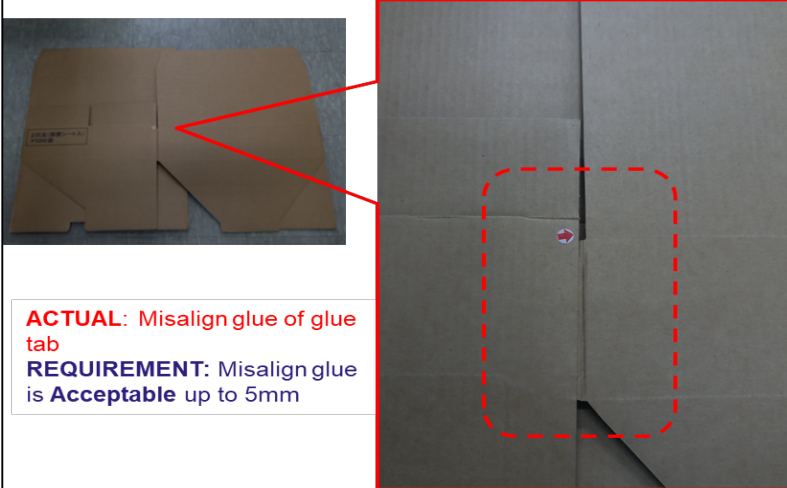
ILLUSTRATION OF THE PROBLEM

Lot Quantity (pcs)	Reject Qty (pcs)	Reject %
2100	30	1.43
Nature of Defect:		
MISALIGN GLUE		
Requirement:		
Misalign glue is Acceptable up to 5mm		
Actual		
Misalign glue of glue tab exceed set tolerance

WHY 1 : Operator got difficulty to trace the alignment during gluing process.

WHY 2 : The creasing line mark is not visible in the smooth surface can not adjust the r ndepth of creasing line to avoid bursting.

WHY 1: Request for tooling relay out regarding putting additional nick mark as guide in gluing alignment.
