**KANEPACKAGE PHILIPPINE INC.**

INVESTIGATION REPORT FORM (IRF)

Customer	EPSON PRECISION PHILS. INC.- ASP/EPLB	Attention To	REXEL ALMARIO
Item Code	513238500	Department	PRODUCTION
Item Description	OUTER CARTON BOX	Date of Detection	250410
Job Order Number	JO25-M-01152-34	Section Detected	QA SCREENING 5

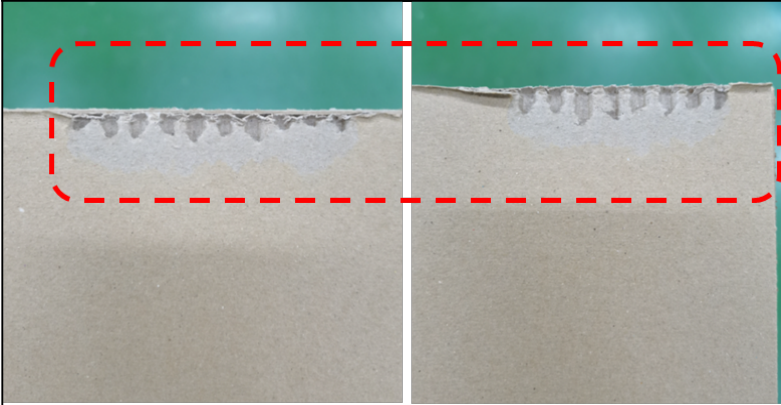
ILLUSTRATION OF THE PROBLEM

PEEL OFF

Maximum of 25mm is still Acceptable

Peel off up to 70mm length

WHY 1 : The liner surface of the board was hit on the feed gate of Eqos during running.

WHY 2 : Presence of excess liner and delamination in the edge of the boards.

WHY 1: Assign Packageworld as main supplier of materials for this item. This based on checking and trial run conducted using materials from Sunpack and Packageworld.
