**KANEPACKAGE PHILIPPINE INC.**

INVESTIGATION REPORT FORM (IRF)

Customer	HIBLOW PHILIPPINES INC.	Attention To	REXEL ALMARIO
Item Code	DB08005130-00	Department	PRODUCTION
Item Description	XP BOX PROTOTYPE OUTER BOX AND INSERT PAD	Date of Detection	250503
Job Order Number	JO25-M-01315-1	Section Detected	QA SCREENING

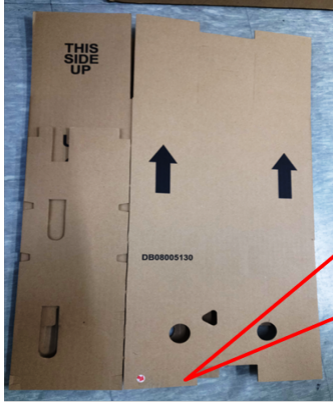
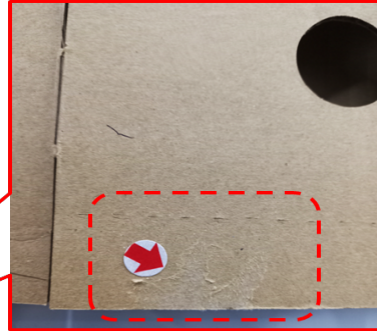
ILLUSTRATION OF THE PROBLEM

Nature of Defect:

PEEL OFF

With peel off up to 30mm

ACTUAL: With peel off up to 30mm**REQUIREMENT:** Acceptable up to 25mm

WHY 1 : PEEL OFF OCCURRED DURING DETACHING PROCESS

WHY 2 : PRESENCE OF UNCUT LINER DURING ETERNA PROCESS

WHY 3 : IMBALANCE DIECUT PRESSURE DUE TO UNEVEN APPLICATION OF BACKING TAPE

WHY 1: APPLICATION OF BACKING TAPE TO THE AFFECTED PORTION
