**KANEPACKAGE PHILIPPINE INC.**

INVESTIGATION REPORT FORM (IRF)

Customer	KOWA-EMORI PHILIPPINES, INC.	Attention To	REXEL ALMARIO
Item Code	HP33D1057-1	Department	PRODUCTION
Item Description	CARTON BOX	Date of Detection	250507
Job Order Number	JO25-M-01645-28	Section Detected	QA SCREENING

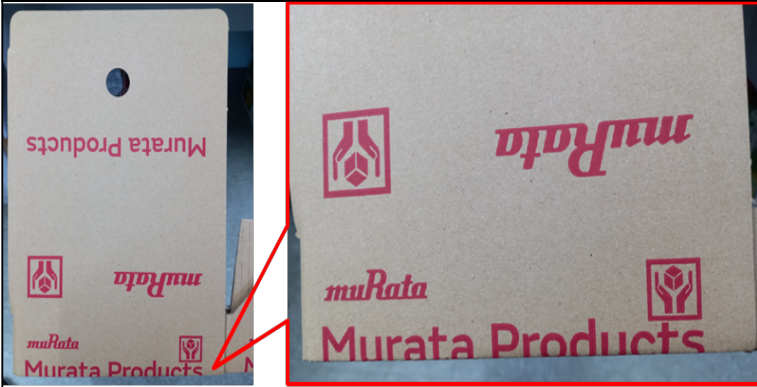
ILLUSTRATION OF THE PROBLEM

ACTUAL: Print overlaps on the creasing line
REQUIREMENT: No misalign print

Lot Quantity (pcs)	Reject Qty (pcs)	Reject %
2000	97	4.85
Nature of Defect:		
MISALIGN PRINT		
Requirement:		
+- 5 mm printing tolerance		
Actual		
Print overlaps on the creasing line

WHY 1 : With almost 2mm slanted mounting of cyrel on the affected portion.

WHY 2 : Cyrel adhesive (double sided tape) got weak.

WHY 3 : Accumulation of water during cyrel cleaning.

WHY 2: Align the slanted portion of cyrel then apply sealant.

WHY 3: Revision of WI PR 001 031 Guidelines for Cyrel Layouting r nregarding inclusion of applying sealant to prevent r naccumulation of water in adhesive during cyrel cleaning.
