**KANE PACKAGE PHILIPPINE INC.**

INVESTIGATION REPORT FORM (IRF)

Customer	BROTHER INDUSTRIES PHILIPPINES, INC.	Attention To	REXEL ALMARIO
Item Code	D028GY001	Department	PRODUCTION
Item Description	CARTON TN FCL X4	Date of Detection	250623
Job Order Number	JO25-M-01987-133	Section Detected	QA SCREENING 3

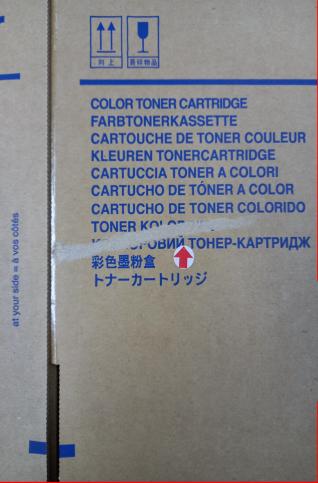
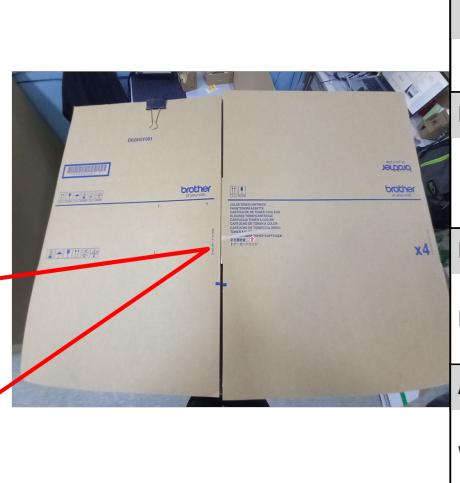
ILLUSTRATION OF THE PROBLEM

Lot Quantity (pcs)	Reject Qty (pcs)	Reject %	
		1450	25	1.72	
Nature of Defect:		PEEL OFF			
Requirement:		PEEL OFF NOT ACCEPTABLE			
Actual		WITH PEEL OFF UP TO 100MM

WHY 1 : The liner peeled off during curing process at conveyor

WHY 2 : The liner stucked on the conveyor belt.

WHY 3 : Presence of excess glue on the glue tab

WHY 4 : Over application of glue.

WHY 1: Reorientation to operators on the proper application of glue and immediately wipe out excess glue using provided rags Production // 2025-07-17

B. Orientation				
Date	2025-07-17		Time	17:01
Title	Reorientation to operators on the proper application of glue and immediately wipe out excess glue using provided rags.			
Attendees	Gluing operators			
Prepared By:			Approved By:	
GERALD DE GUZMAN 250717			N/A	
			Department Head
