**KANE PACKAGE PHILIPPINE INC.**

INVESTIGATION REPORT FORM (IRF)

Customer	KOWA-EMORI PHILIPPINES, INC.	Attention To	REXEL ALMARIO
Item Code	HP33D1057-1	Department	PRODUCTION
Item Description	CARTON BOX	Date of Detection	250813
Job Order Number	JO25-M-02512-42	Section Detected	QA SCREENING 4

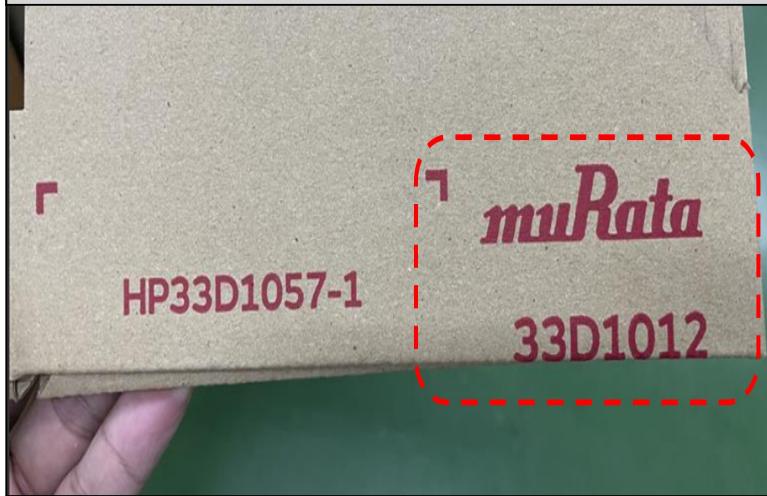
ILLUSTRATION OF THE PROBLEM

MISALIGN PRINT

Printing tolerance +5mm

Print overlaps on the creasing line

WHY 1 : Misaligned diecut at Eterna

WHY 2 : Random delayed feeding of materials.

WHY 3 : Encountered malfunction of the rubber roller.

WHY 4 : Worn out timing belt of the Eterna machine

WHY 1: Replacement of the worn out timing belt.

Engineering/Production //
2025-09-09WHY 2: Replacement of acrylic cover to monitor the condition of timing belt and inclusion of checking in
Eterna DMCEngineering/Production //
2025-09-30
