INVESTIGATION REPORT FORM (IRF)

Customer	BROTHER INDUSTRIES PHILIPPINES, INC.	Attention To	REXEL ALMARIO
Item Code	D02RN1001	Department	PRODUCTION
Item Description	CARTON DEV UNIT ELLE (X3)	Date of Detection	251004
Job Order Number	JO25-M-03051-36	Section Detected	QA SCREENING 5

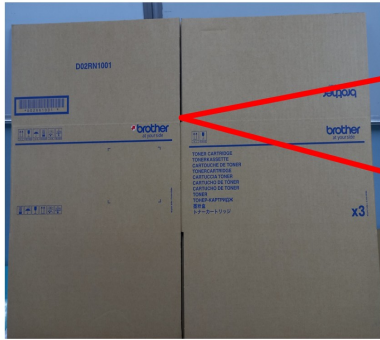
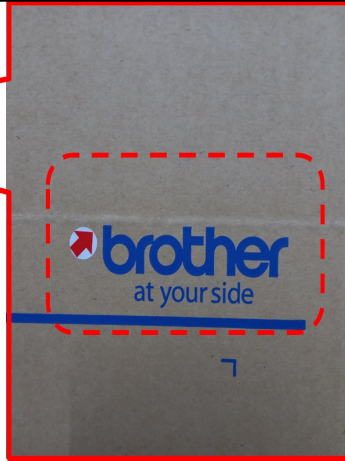
ILLUSTRATION OF THE PROBLEM

Actual: 3mm misalign print
Requirement: 17mm (tolerance:+5/-0)

Lot Quantity (pcs)	Reject Qty (pcs)	Reject %
1400	60	4.29
Nature of Defect:		
MISALIGN PRINT		
Requirement:		
17mm (tolerance:+5/-0)		
Actual		
3mm misalign print

WHY 1 : Misaligned diecut at Eterna.

WHY 2 : Random delayed feeding of materials.

WHY 3 : r n Stucked up bearing at feeder roller (findings during Eterna machine maintenance c/o Supplier) r n and worn out engineering plastic in the gripper bar causing misalign gripped.

WHY 1: Replacement of worn out machine part.
