**KANEPACKAGE PHILIPPINE INC.**

**INVESTIGATION REPORT FORM (IRF)**

Customer	KOWA-EMORI PHILIPPINES, INC.	Attention To	REXEL ALMARIO
Item Code	HP01D2200C-1	Department	PRODUCTION
Item Description	CARTON BOX W/ PRINT	Date of Detection	251022
Job Order Number	JO25-M-03108-13	Section Detected	QA Screening 4

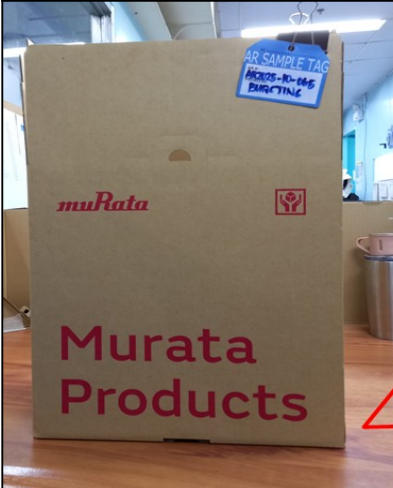
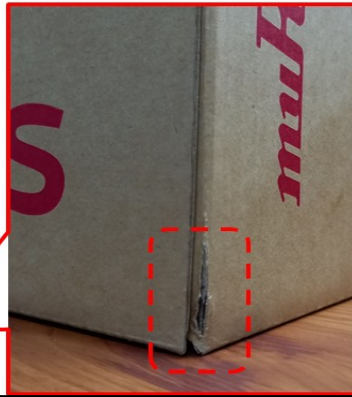
**ILLUSTRATION OF THE PROBLEM**

Nature of Defect:

BURSTING

Actual

WITH BURSTING

WHY 1 : Excessive pressure along the creasing line

WHY 2 : Due to creasing blade was aligned too close to the creasing matrix.

WHY 3 : Misalignment of creasing matrix occurred due to adhesive was already worn out.

WHY 1: Replacement of worn out creasing matrix
