**KANEPACKAGE PHILIPPINE INC.**

INVESTIGATION REPORT FORM (IRF)

Customer	SANYO DENKI PHILS INC.	Attention To	REXEL ALMARIO
Item Code	00902010-01	Department	PRODUCTION
Item Description	PRINT SPECIFICATION	Date of Detection	251024
Job Order Number	JO25-M-03229-74	Section Detected	QA SCREENING 2

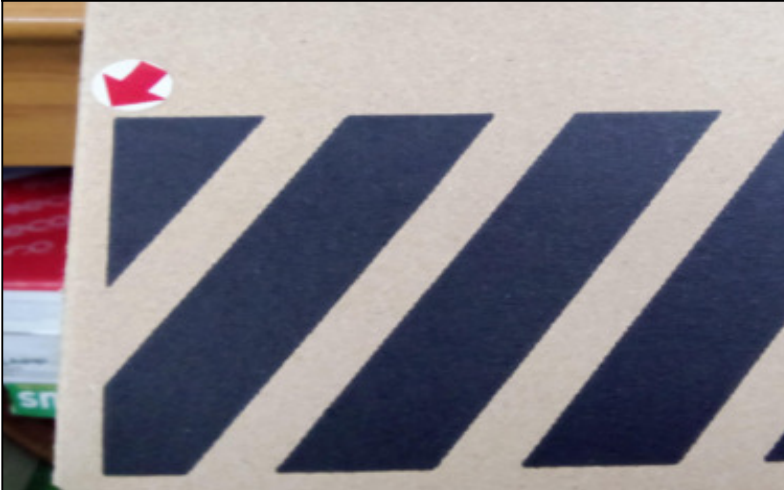
ILLUSTRATION OF THE PROBLEM

Lot Quantity (pcs)	Reject Qty (pcs)	Reject %
1000	38	3.80
Nature of Defect:		
MISALIGN PRINT		
Requirement:		
Solid black print within the folding line (Printing tolerance: +-3mm)		
Actual		
Misalign up to 5mm

WHY 1 : W1 The volume of items loaded into the feeder is too heavy. r nW2 The operator fed the materials beyond the standard height limit of 300mm for EB flute. r nW3 The operator has difficulty checking the standard height limit marking from time to time during feeding.

WHY 1: PR for Line Laser Marker to help operators easily identify the standard feeding height limit.
