**KANEPACKAGE PHILIPPINE INC.**

INVESTIGATION REPORT FORM (IRF)

Customer: EPSON PRECISION PHILIPPINES INCORPORATED - IJP

Item Code: 5150864-01

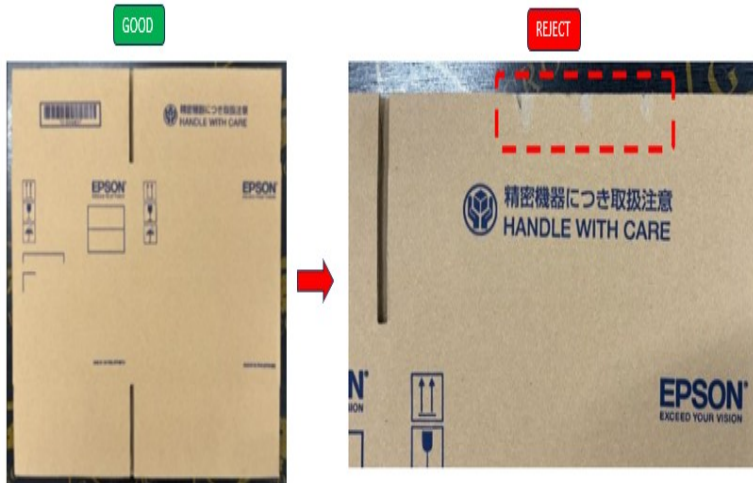
ILLUSTRATION OF THE PROBLEM

PEEL OFF

PEEL OFF OCCUR ON THE UPPER FLAP CLASS B

WHY 1 : Peel off occur during stripping process on diecut

WHY 2 : During the stripping process the nick mark was not fully cut resulting to peel off

WHY 3 : Numerous nick mark was observed on the cutting mark

WHY 4 : Numerous nick was made to avoid loose board

WHY 1: standardize the position of the nick mark on the gripper side and put marking on the pattern sheet of the location of the nick mark to avoid patching on the said area

WHY 1: strengthen the control on the changes of the blade layout by implementing on the request for tooling relay out from approval
