**KANEPACKAGE PHILIPPINE INC.**

INVESTIGATION REPORT FORM (IRF)

Customer	EPSON PRECISION PHILIPPINES INCORPORATED - IJP	Attention To	WEENA APALLA
Item Code	5165913-00	Department	KP LIMA PRODUCTION
Item Description		Date of Detection	260112
Job Order Number	JOL-0024101	Section Detected	lamination 2

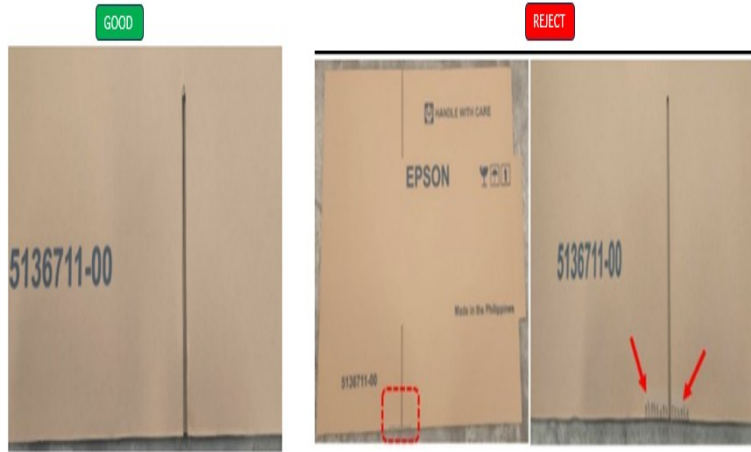
ILLUSTRATION OF THE PROBLEM

Lot Quantity (pcs)	Reject Qty (pcs)	Reject %
1600	64	4.00

Nature of Defect:

GLUE STAIN

GLUE STAIN ION ACTUAL/APPEARANCE

WHY 1 : The gate valve of the water supply is damage.

WHY 1 : Main supply of water has been turned off

WHY 1 : The defect is not detectable until it did not reach on the catcher. Affected units are inside the conveyor belt.

WHY 1: Change the gate valve of the water supply of lamination machine

Engineering // 2026-01-20
