**KANEPACKAGE PHILIPPINE INC.**

**INVESTIGATION REPORT FORM (IRF)**
☒ Inhouse Detection

Customer	EMORI	Attention To	Mr. Gerald De Guzman
Item Code	HP01D2200C	Department	PRODUCTION
Item Description	CARTON BOX	Date of Detection	20 09 29
Job Order Number	WO-DRS-20-M-01183-61	Section Detected	QA - IN LINE

## INVESTIGATION REPORT FOR POOR PRINT OF EMORI HP01D2200C CARTON BOX

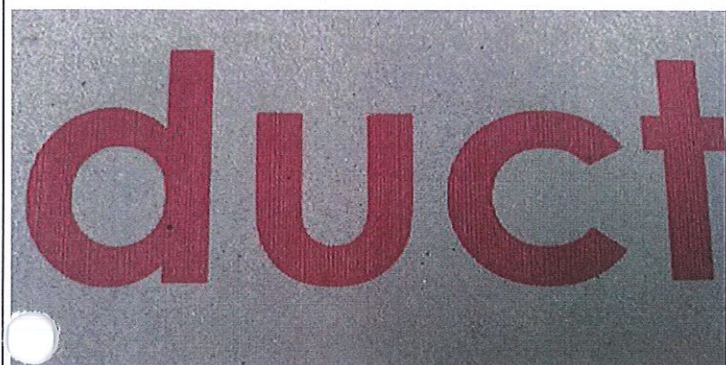
**ILLUSTRATION OF THE PROBLEM**
☐ Major

POOR PRINT

There should be no lining on the logo of the item

W/ lining on the logo

Presence of water on the surface of the cyrel because the operator does not dried properly the rubber die

<b>DIRECT CAUSE PROCESS/MATERIAL</b>	W1- Only 26/3,020pcs are affected and this is the 1st process that time with red print, so ink might still be fresh
	W2- Possible it happened after the Eqos operator clean the cyrel due to sudden machine stop.
	W3- Possible that after cleaning of cyrel, operator was not able to completely dry the cyrel using dry rags, leaving water residue on the cyrel

<b>INDIRECT CAUSE (OUTFLOW) PROCESS/MATERIAL</b>	W1- Possible its more visible when the print is fully dried, why the operator didn't trap the occurrence lining appearance in print.
--	--

Clean the cyrel using of 2 rags to assure that the cyrel is totally dry.

Orient the operator to make sure that cyrel is totally dried after cleaning by using a dry rags.
