INVESTIGATION REPORT FOR PEEL OFF OF 516298200 LOUVRE 2 MCX ASIA

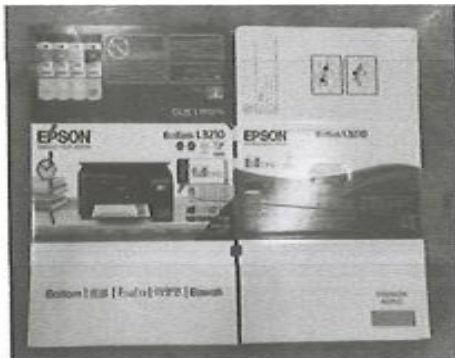
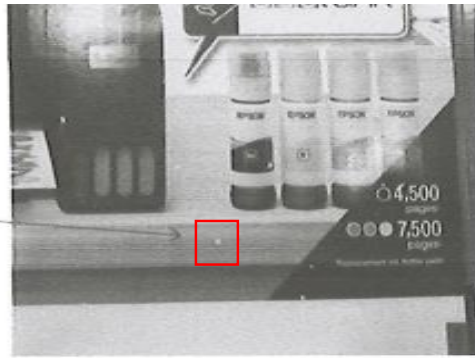
W1: Peel off occurred due to splashing.

W2: During running the glue was sprinkled in the glue roller to the splashing cover.

W3: Due to high glue viscosity

> Cleaning of splashing cover for every 500pcs
