# INVESTIGATION REPORT FOR MISALIGNED CUT OF 516387900 LOUVRE 2 MDX

## DIRECT CAUSE METHOD (MACHINE)

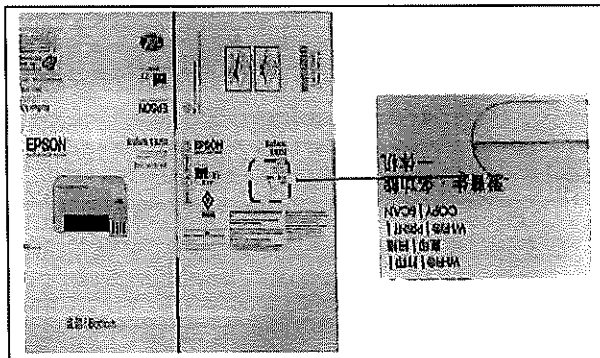
W1: Misaligned cut occurred in the handhole portion with cut on the Japanese character on diecut 1.

W2: There were an issue in the machine when running printed items.

W3: The three gripper were to be replaced and the bearing due to worn out.

- > Checking of schedule to engineering for checking the gripper to Sir Peter.
- > Waiting for spare parts.
