**KANEPACKAGE PHILIPPINE INC.**

# INVESTIGATION REPORT

GLUE STAIN

LINUS FAL ASIA

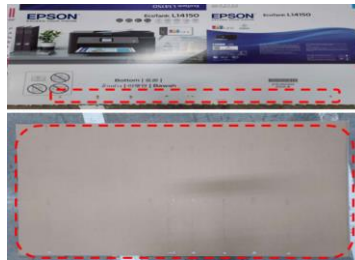
INHOUSE DETECTION: Glue Stain  
LOT SIZE: 300 PCS  
REJECT QUANTITY: 140  
REJECTION RATE: 46.67%  
JO: 25010  
REMARKS: Glue Stain occurred on the bottom flap and on the back surface of the panel.

WHY 1: Glue Stain occurred on the bottom flap and on the back surface of the panel.

WHY 2: There's a possibility that the plate is accumulated with glue

WHY 3: The operator failed to notice if the glue plate is still in good condition

- > Orient the operators regarding the issue.
- > Setting a standard of weekly checking and cleaning of glue plate.
