MINUTES OF MEETING

K KANEPACKAGE PHILIPPINE INC.

AGENDA: 31. DISCUSS THE EXCESS GLUE ENCOUNTERED IN ITEM CODE 816298200 (LOUNGE & MICK ICB FOR ALIA, C)

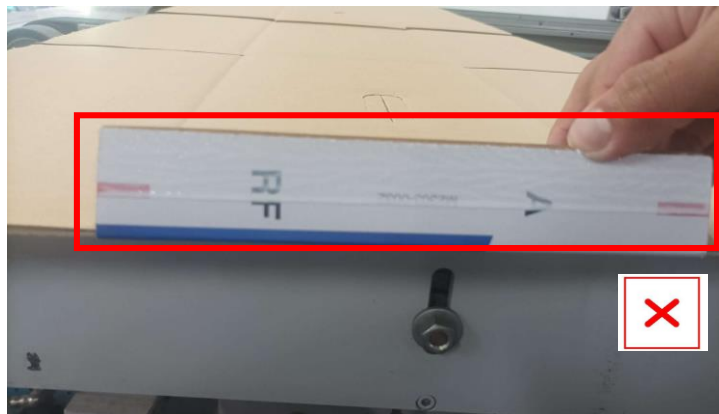
APPLICATION OF GLUE IN THE EDGE
OF THE GLUE TAB
(IMPROPER)

MINUTES:
 WHY 1: PEEL OF ENCOUNTERED IN ITEM CODE 816298200 (LOUNGE & MICK ICB FOR ALIA, C) DURING PROCESS
 WHY 2: PEEL OFF CAUSED BY EXCESS GLUE
 WHY 3: THERE WAS EXCESS GLUE BECAUSE THE 2ND GLUE WAS APPLIED FURTHER INSIDE THE PANEL AWAY FROM THE GLUE TAB
 WHY 4: THICK GLUE GOT ON THE EDGE OF THE GLUE TAB SO THERE WAS AN EXCESS INSIDE THE PANEL WHEN THE OPERATOR MOVED THE GLUE ROLLER, AFFECTING THE PLACE OF THE GLUE ROLLER APPLICATION BECAUSE THE ROLLER MOVED AWAY FROM THE GLUE TAB OF THE PANEL
 NOTE: THE OPERATOR SHOULD HAVE ADJUSTED THE GLUE PLATE BECAUSE HE NOTICED THE UNEVEN GLUE ON THE ROLLER
 WHY 5: OPERATOR ALSO FAILED TO UNDORED TRIAL AFTER THE ADJUSTMENT OF THE GLUE PLATE
 IMPLEMENTATION: THAT EVERY ADJUSTMENT THEY MUST UNDERGO TRIAL SAMPLES

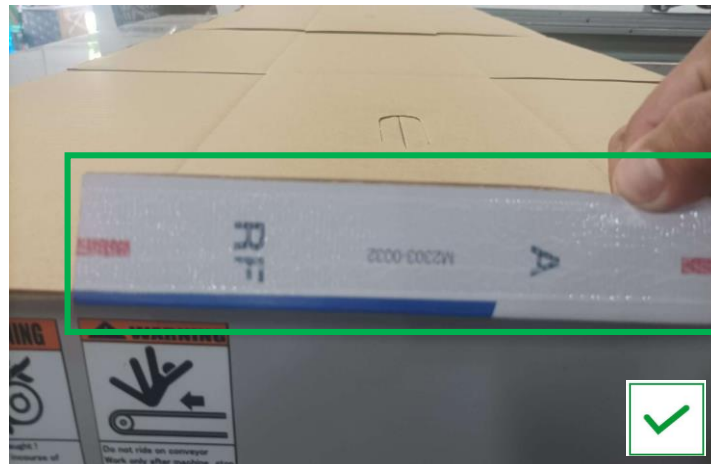
APPLICATION OF GLUE WITH
ALLOWANCE BEFORE THE EDGE
(PROPER)
