# Investigation Report for Peel Off of Kowa Emori HP01D2000-3 Carton Box

CONTROL No:	IRF - 703			REJECT PERCENTAGE:	1.81%
REJECT QTY:	163	LOT QTY:	9000

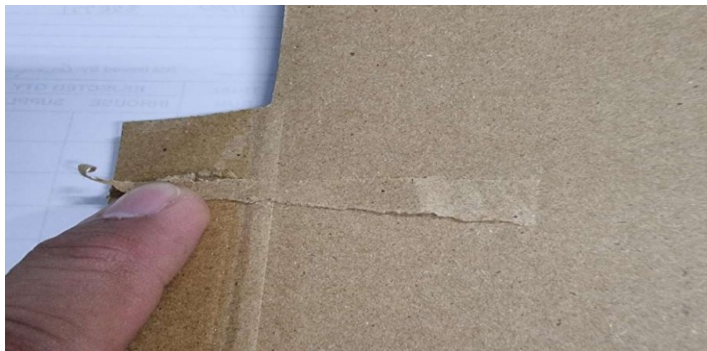
DIRECT CAUSE	W1	The caused of feel off is the uncut kraft liner skin.
	W2	There's a factor that the backing tape in the pattern film on that portion got broken due to multiple shot that result to small uncut of kraft liner skin..
	W3	The uncut of kraft liner skin resulting to peel off since the item underwent auto stripping process in Eterna.

INDIRECT CAUSE (OUTFLOW)	W1	Eterna operator notice the peel off during sampling and immediately inform the leader in-charge and separate the affected, Gluing operator try if can rework by applying glue but it is visible.
-----------------------------	----	--

Since broken of backing tape is uncontrollable due to multiple shot our action plan is to put additional backing tape on the affected portion every time the operator encounter peel off.	PIC:	Production	TARGET DATE:	On going
---	------	------------	--------------	----------
