KANEPACKAGE PHILIPPINE INC. No. 5 Ring Road LISP II, Brgy. La Mesa, Calamba City, Laguna Telephone No. (049) 545-7166 to 69 Fax No. (049) 545-6302	<h1>INVESTIGATION REPORT</h1>		
	Prepared By:	Check By:	Approved By:
	K.DIAZ QA-IE/ Prodn IE	N. CEPEDA QA/ Prodn SV	R. MIRANDA KPLIMA Operations Gen. Mngr.
DATE:	OCTOBER 17, 2023

1.1. ISSUE:	
	INVERTED CUT
1.2. ITEM DESCRIPTION:	
PART CODE:	516387500
PART NAME:	CARTON BOX
1.3. BACKGROUND:	
PICTURE

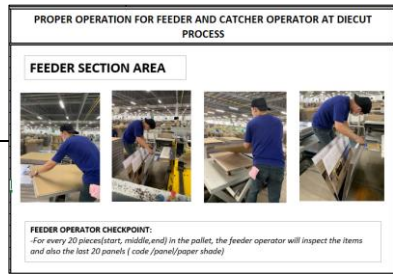
WHY 2:	WHY THE OPERATOR MISFEED THE ITEM? THE OPERATOR BYPASS THE MANUAL BROWSING OF THE ITEM.

<p>FEEDER SECTION AREA</p> <p>FEEDER OPERATOR CHECKPOINT: -For every 20 pieces(start, middle,end) in the pallet, the feeder operator will inspect the items and also the last 20 panels (code /panel/ paper shade)</p>
WHY 3:	WHY THE OPERATOR BYPASS THE MANUAL BROWSING? THE OPERATOR FAIL TO DO THE GUIDELINES OF PROPER FEEDING AND CHECKPOINTS OF ITEMS.	
WHY 4:	WHY THE OPERATOR FAIL TO DO THE GUIDELINES? BECAUSE THE NEW FEEDER OPERATOR IS IN TRAINING.

RE-EDUCATE THE OPERATORS FOR TIGHTENING THE MANUAL BROWSING AND PROPER FEEDING OF ITEMS.

INFORM THEIR SUBLEADER OR SENIOR OPERATOR FOR ANY ABNORMALITIES BEING ENCOUNTERED.
